Manhole Inspection Summary

Manhole # S17II1019MH

Insp Date: 1/11/07 9:38 AM

Location Address: **2206 GORDON RD**

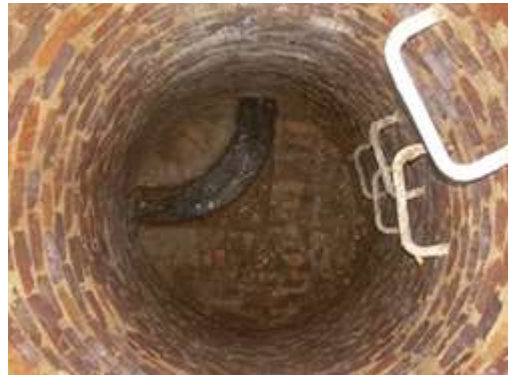
Top View

Bench ☒ Exists Material: **Brick** ☐ Parged ☒ **Debris** (not Condition related)

Channel Material: **Brick** ☐ Parged ☒ **Debris** (not Condition related)

Bench and Channel debris.

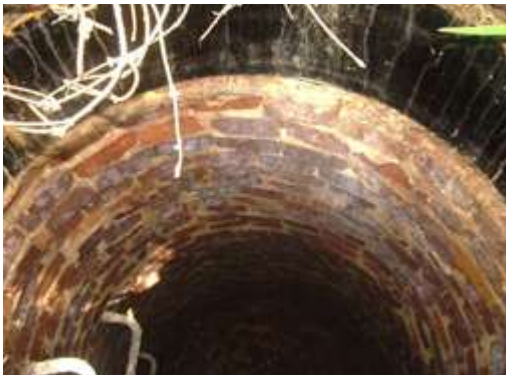
Defect

Infiltration: ☐ None ☒ **Joint** ☐ Cracks ☐ Mortar ☐ Roots ☒ **Wall**

Infiltration: ☐ None ☐ Joint ☐ Cracks ☐ Mortar ☐ Roots ☒ **Wall**

Corbel and Barrel infiltration - other side.

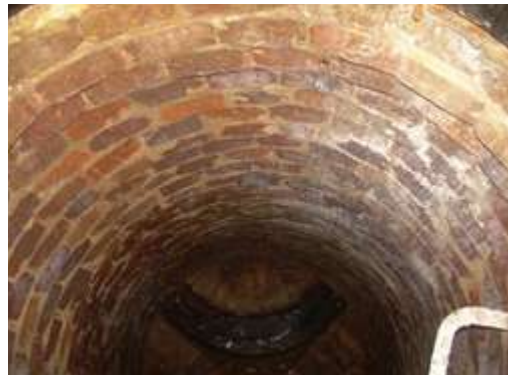
Defect

Corbel and Barrel infiltration.

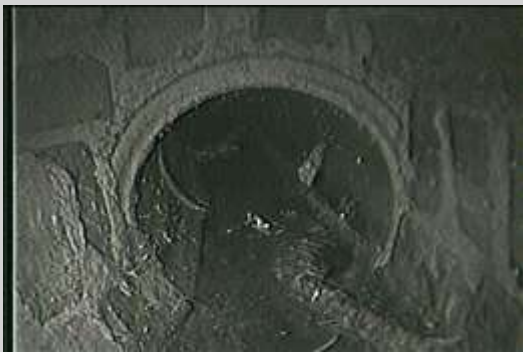
8 in. Circular Gravity Sewer Pipe Out @ 12 O'Clock

Deposits: ☐ None ☒ **Mud** ☐ Sludge ☒ **Debris** ☐ Grease

Silt Depth: **0** (in.) Deposits Extent: **Light**

Infiltration: **None** Pipe Seal Cond: **Cracked**

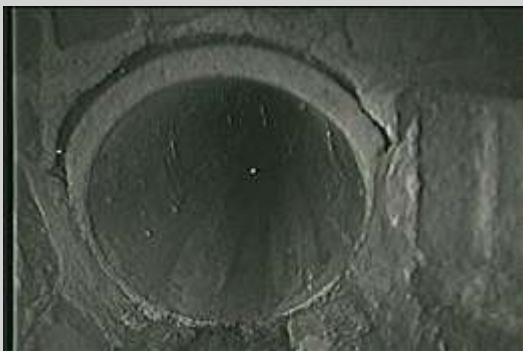
8 in. Circular Gravity Sewer Pipe In @ 9 O'Clock

Comments **Unable to open 1st visit. OPENED AND INSPECTED 5/7. The I9 pipe seal is not flush to the pipe.**

Infiltration: **None** Pipe Seal Cond: **Unknown**
